NASA CR-72789

# **8,000-HOUR LIFE TEST OF AN ELECTRON BOMBARDMENT MERCURY ION THRUSTER SYSTEM FOR SERT II**

FINAL REPORT

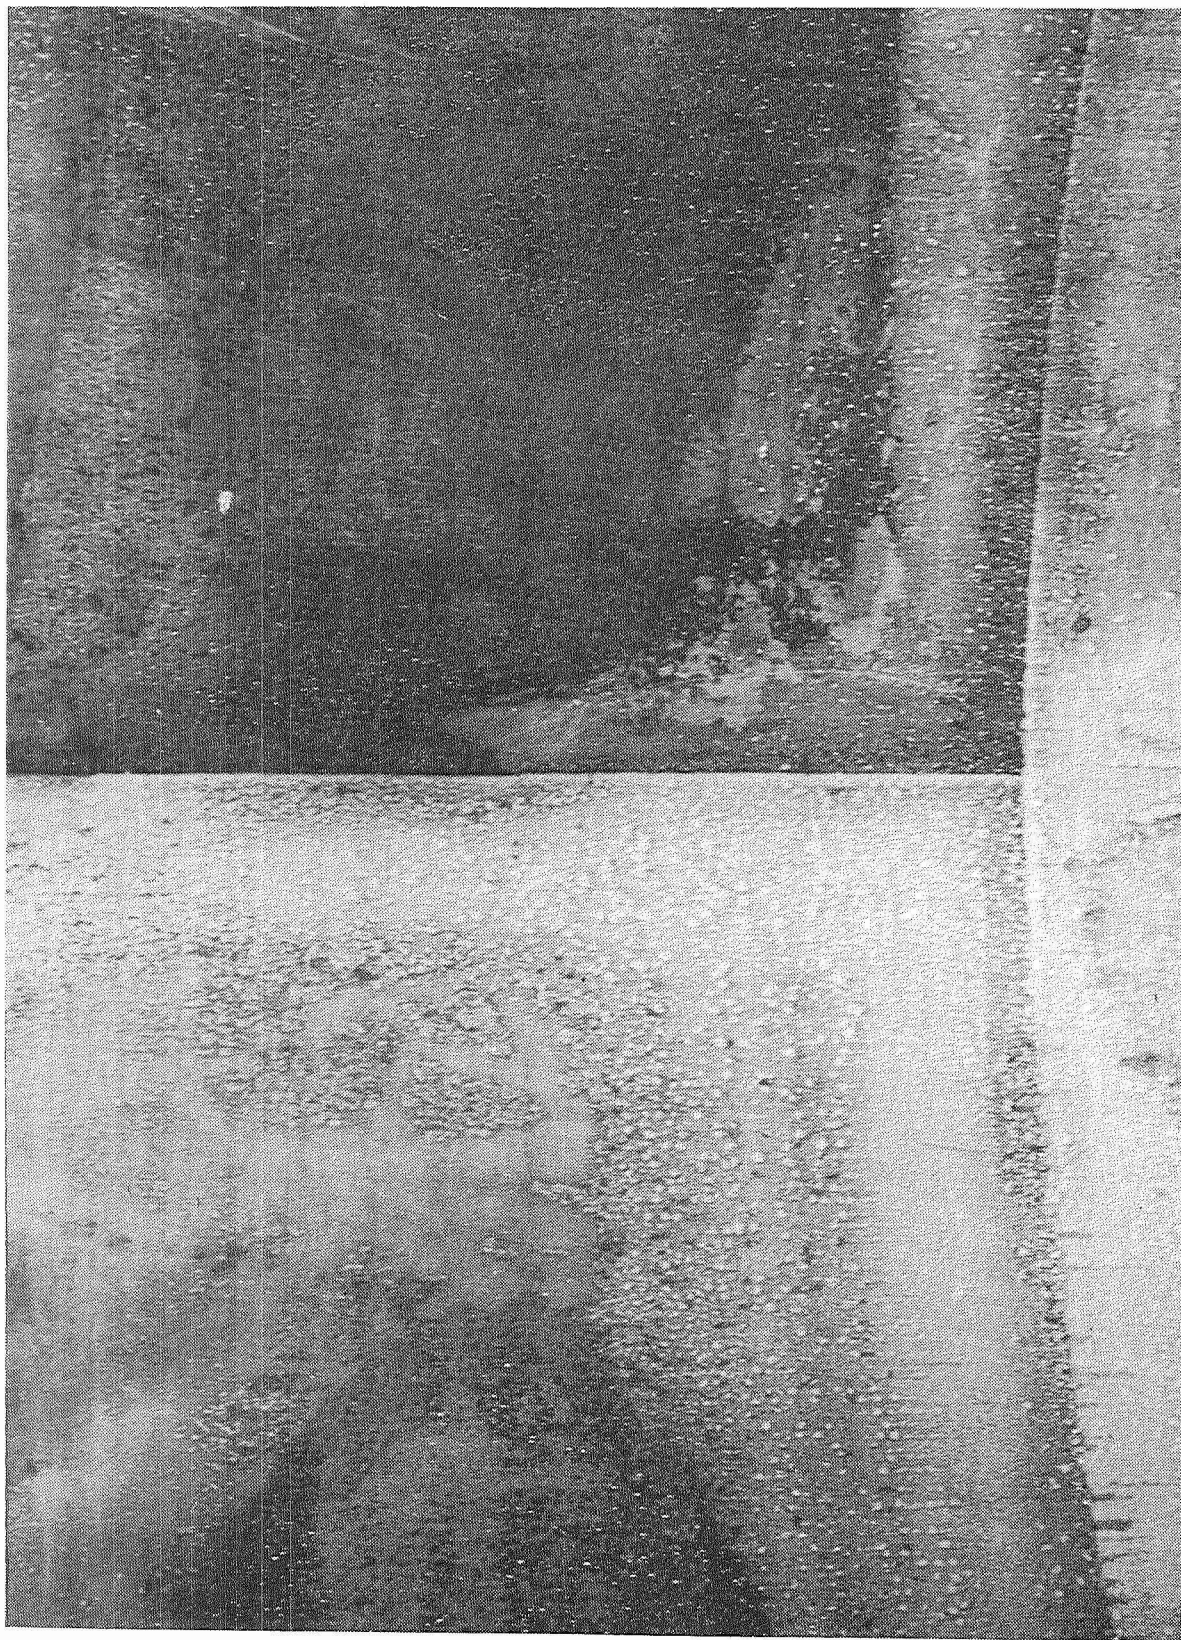
FIGURE 30 COLD LINER AND MERCURY SURFACE WITH DEPOSITS AFTER RUN NO. 9
